**Flood Control Project Maintenance
Levee Inspections**

Fall 2010 Levee Maintenance Deficiency Summary Report

San Joaquin River Basin

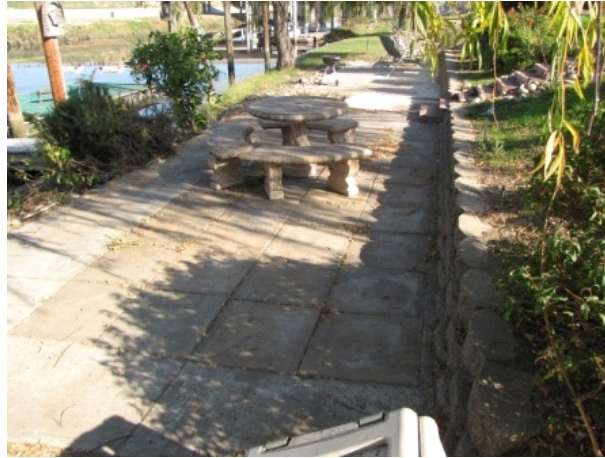
View of a retaining wall and patio with furniture in the waterward toe and berm looking upstream.

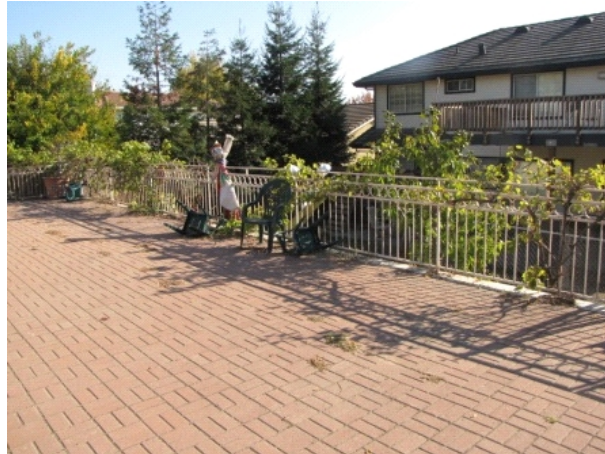
Levee Mile Report Line	24
Start Levee Mile	0.83
End Levee Mile	0.84
Location	Land Side
Category	Earthen Levee
Item	Encroachments

View of a fence on top of a large retaining wall in the landward slope looking upstream. Landscaping is growing along the fence.

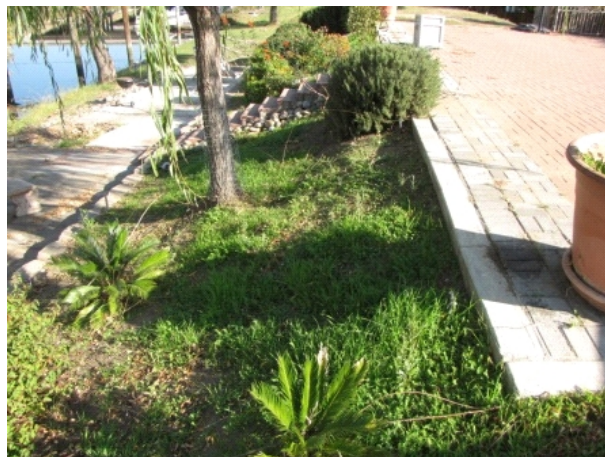
Levee Mile Report Line	25
Start Levee Mile	0.83
End Levee Mile	0.84
Location	Water Side
Category	Earthen Levee
Item	Encroachments

View of landscaping and irrigation on the waterward slope looking upstream.

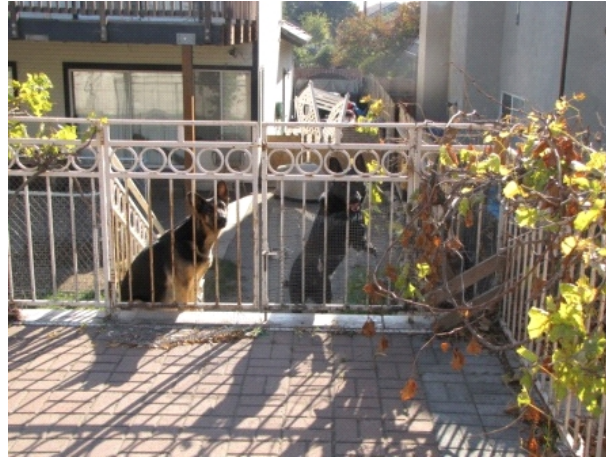
View of steps on the landward slope and dogs preventing a closer inspection.

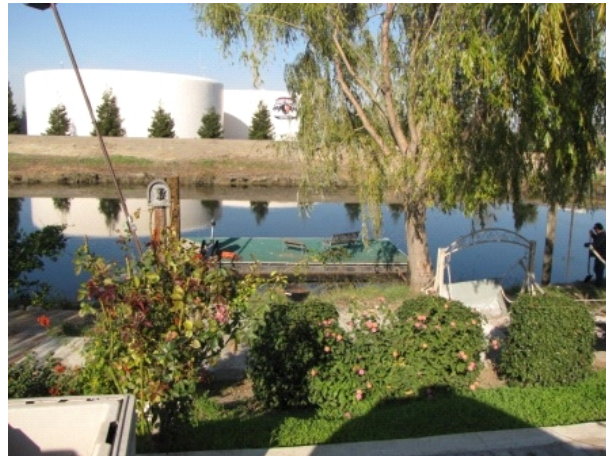
Levee Mile Report Line	28
Start Levee Mile	0.84
End Levee Mile	0.84
Location	Water Side
Category	Earthen Levee
Item	Encroachments

View of a dock on the waterward side of the berm.

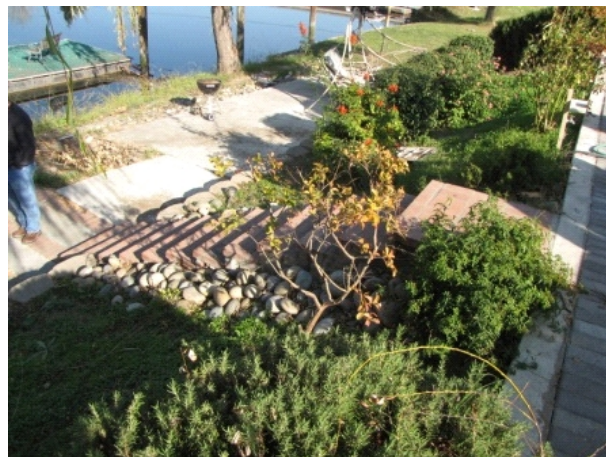
Levee Mile Report Line	29
Start Levee Mile	0.84
End Levee Mile	0.84
Location	Water Side
Category	Earthen Levee
Item	Encroachments

View of steps on the waterward slope of the levee looking upstream.

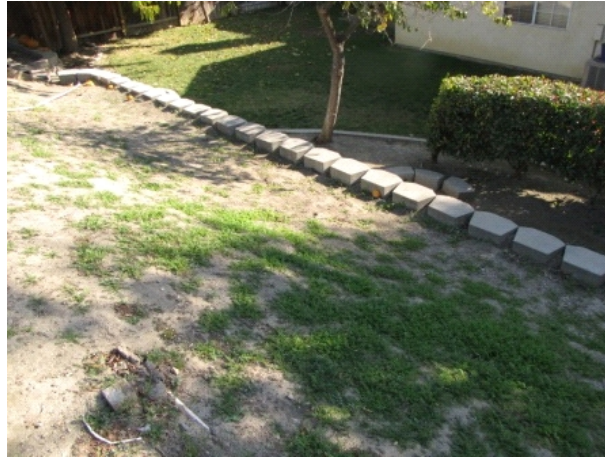
View of a retaining wall in the landward slope.

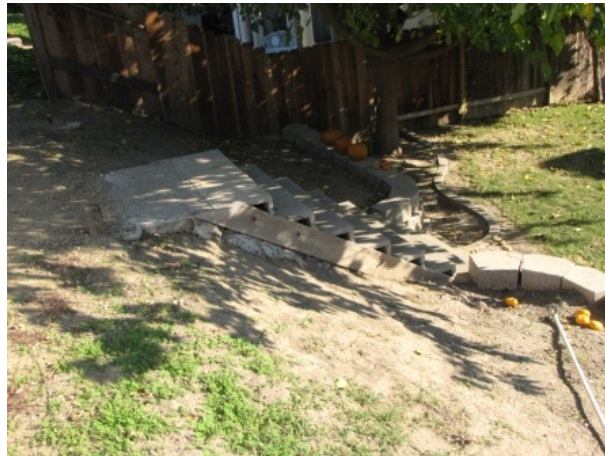
Levee Mile Report Line	31
Start Levee Mile	0.85
End Levee Mile	0.85
Location	Land Side
Category	Earthen Levee
Item	Encroachments

View of steps on the landward slope looking upstream.

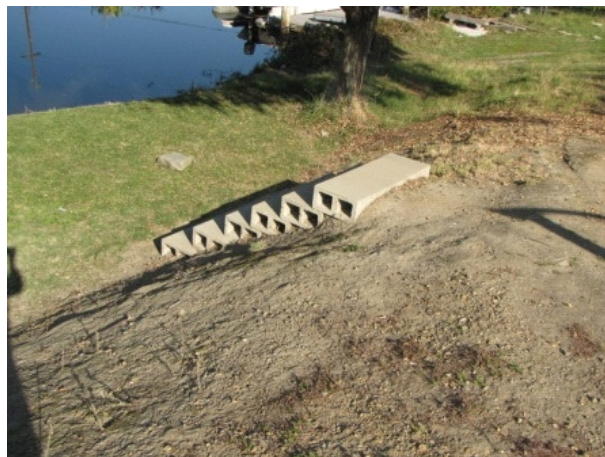
Levee Mile Report Line	32
Start Levee Mile	0.85
End Levee Mile	0.85
Location	Water Side
Category	Earthen Levee
Item	Encroachments

View of steps on the waterward slope looking upstream.

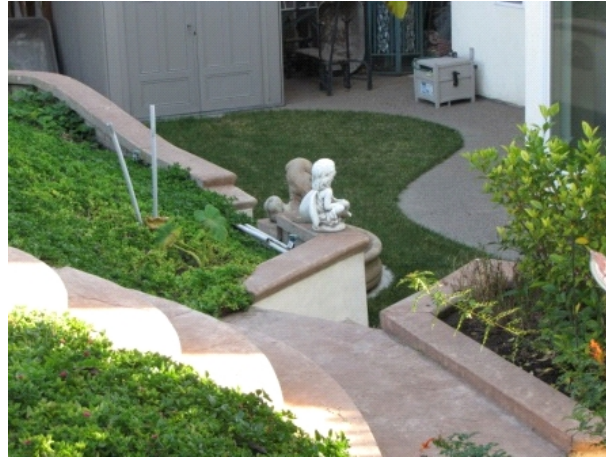
View of a retaining wall and patio in the landward slope.

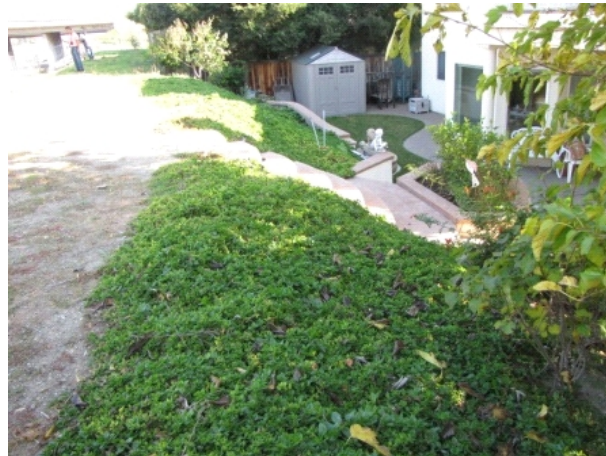
Levee Mile Report Line	34
Start Levee Mile	0.85
End Levee Mile	0.87
Location	Land Side
Category	Earthen Levee
Item	Encroachments

View of landscaping and irrigation on the landward slope looking upstream.

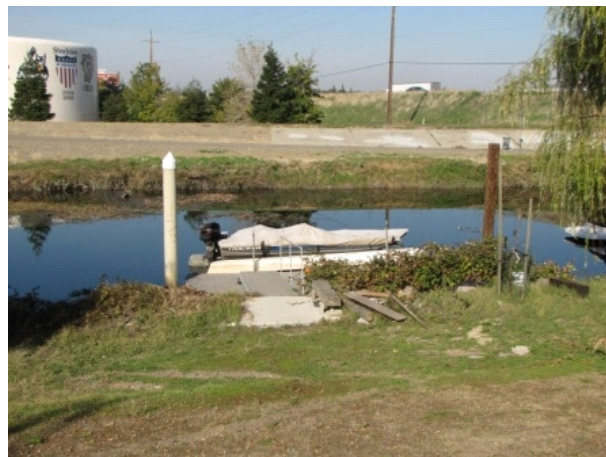
Levee Mile Report Line	35
Start Levee Mile	0.86
End Levee Mile	0.86
Location	Water Side
Category	Earthen Levee
Item	Encroachments

View of a dock and concrete pad on the waterward side of the berm.

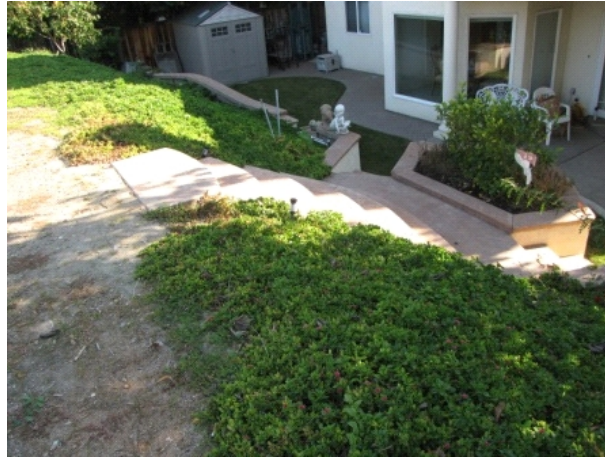
View of steps on the landward slope looking upstream.

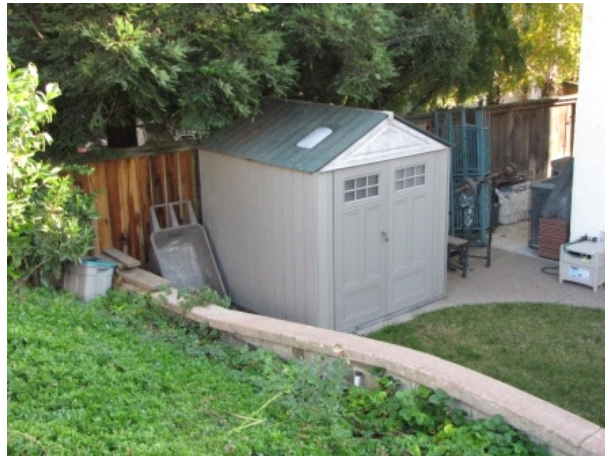
Levee Mile Report Line	37
Start Levee Mile	0.87
End Levee Mile	0.87
Location	Land Side
Category	Earthen Levee
Item	Encroachments

View of a shed located at the landward toe looking upstream.

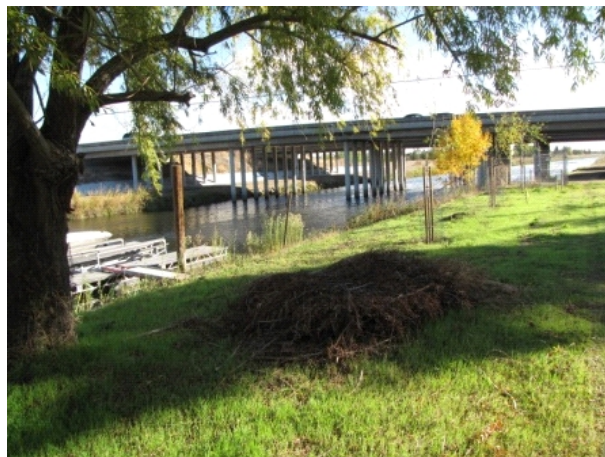
Levee Mile Report Line	38
Start Levee Mile	0.87
End Levee Mile	0.87
Location	Water Side
Category	Earthen Levee
Item	Encroachments

View of a prunings pile on the waterward berm looking upstream.

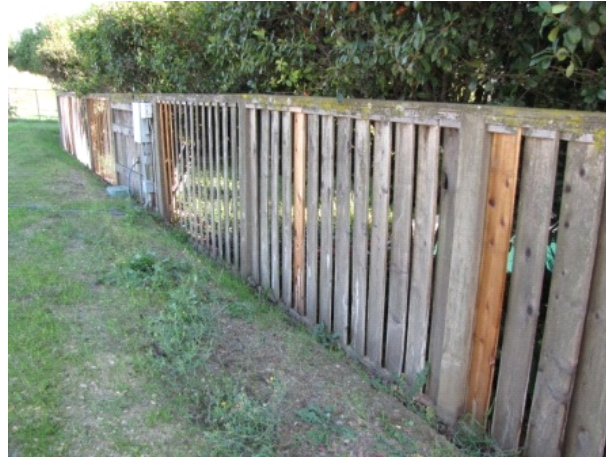
View of a fence at the landward shoulder blocking visibility and access looking upstream. Some encroachments can be seen through the fence but not with any detail. Also visible is an electrical panel and hose bib.

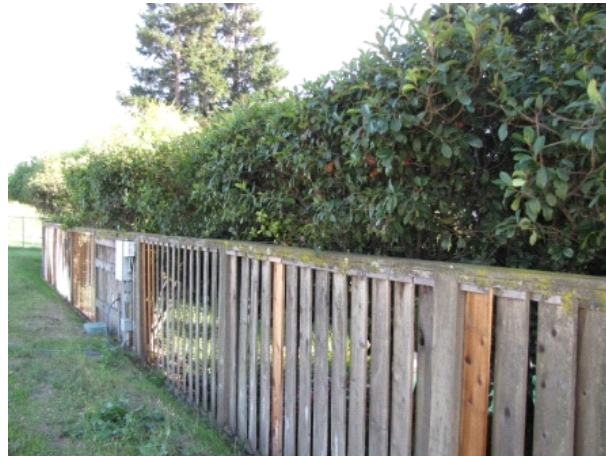
Levee Mile Report Line	40
Start Levee Mile	0.87
End Levee Mile	0.88
Location	Land Side
Category	Earthen Levee
Item	Encroachments

View of bushes above the fence at the landward shoulder further obstructing visibility looking upstream.

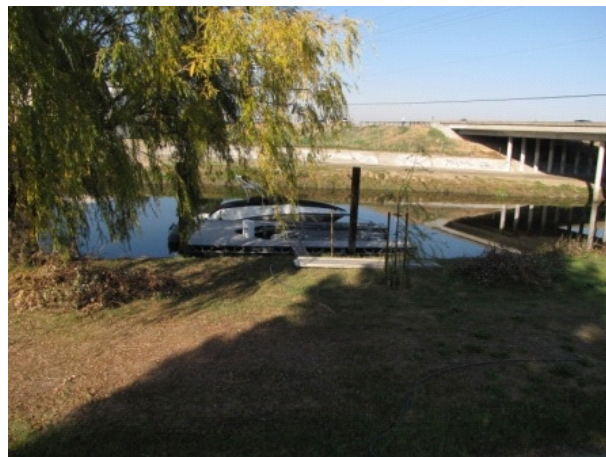
Levee Mile Report Line	41
Start Levee Mile	0.88
End Levee Mile	0.88
Location	Water Side
Category	Earthen Levee
Item	Encroachments

View of a dock on the waterward side of the berm.

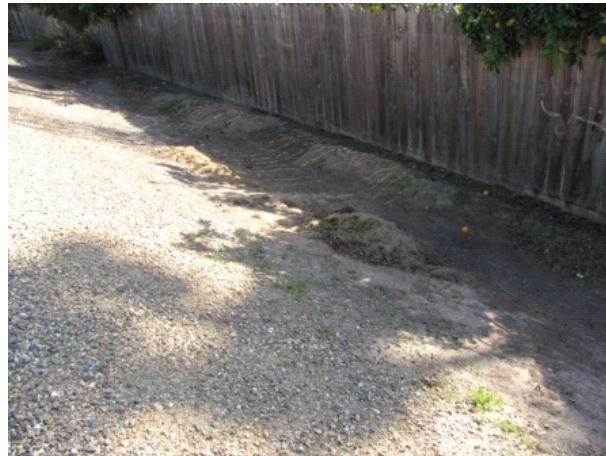
View of lawn clippings placed at the landward toe.

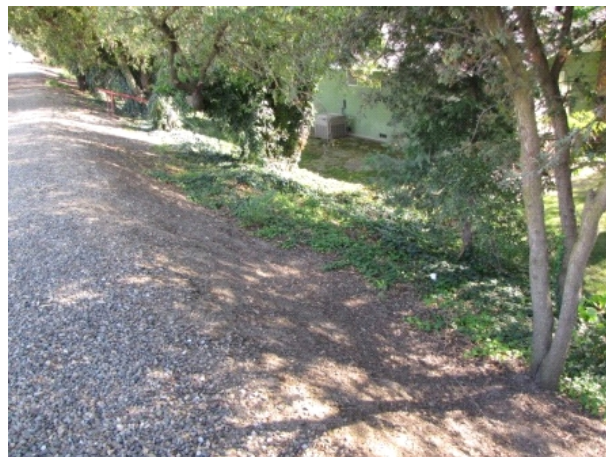
Levee Mile Report Line	66
Start Levee Mile	2.04
End Levee Mile	2.07
Location	Land Side
Category	Earthen Levee
Item	Encroachments

View of landscaping along the landward slope looking upstream. County crews have greatly reduced the amount of material and increased visibility and access.

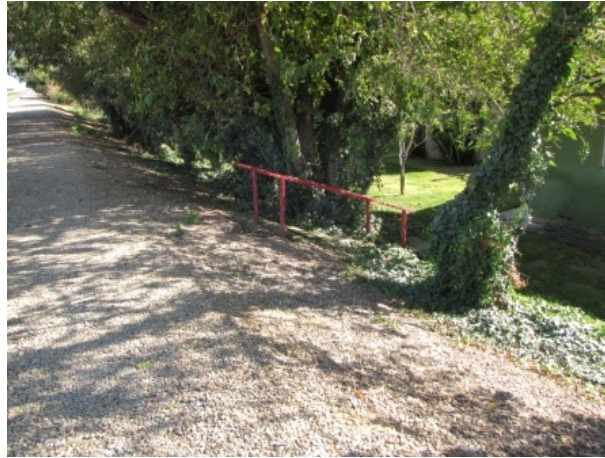
View of steps dug into the landward slope looking upstream.

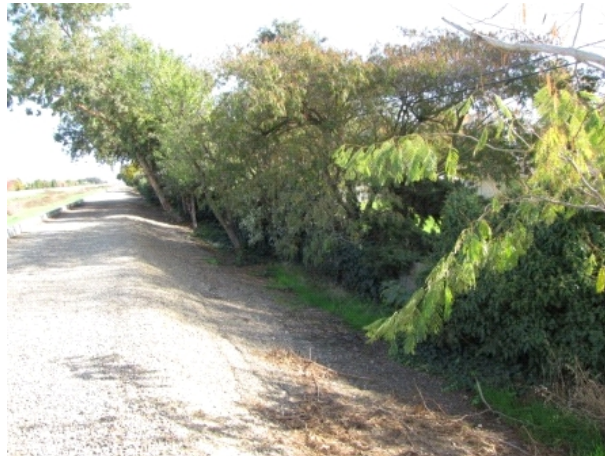
Levee Mile Report Line	68
Start Levee Mile	2.11
End Levee Mile	2.14
Location	Land Side
Category	Earthen Levee
Item	Encroachments

View of a fence with landscaping growing on it at the landward toe looking upstream.

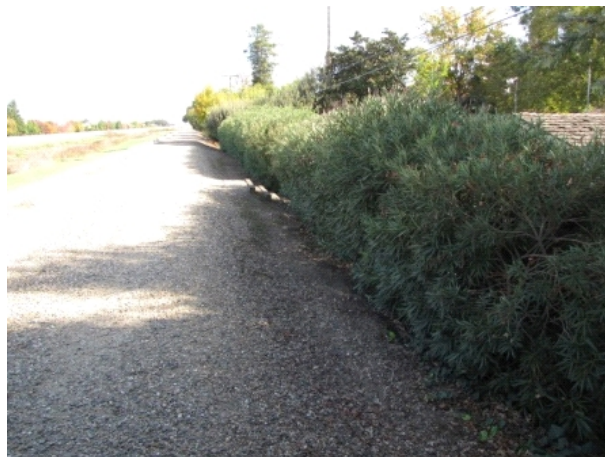
Levee Mile Report Line	69
Start Levee Mile	2.14
End Levee Mile	2.16
Location	Land Side
Category	Earthen Levee
Item	Encroachments

View of landscaping along the landward slope looking upstream.

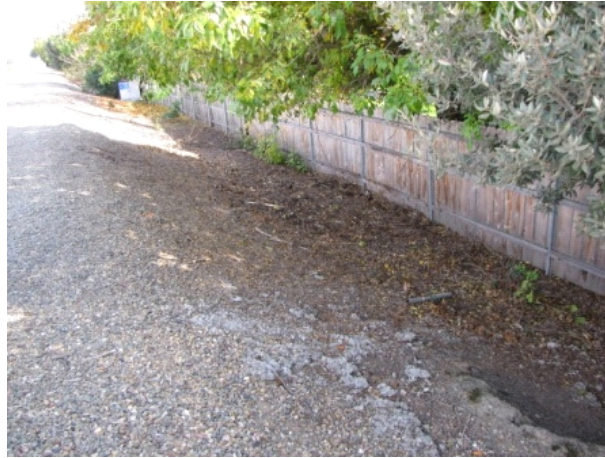
View of a fence along the landward toe looking upstream.

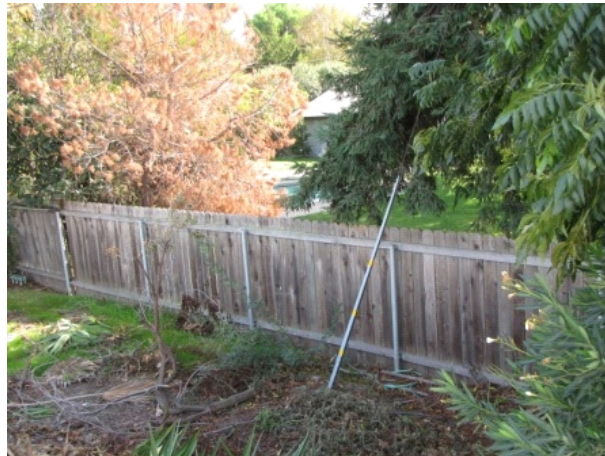
Levee Mile Report Line	73
Start Levee Mile	2.19
End Levee Mile	2.25
Location	Land Side
Category	Earthen Levee
Item	Encroachments

View of a fence along the landward toe.

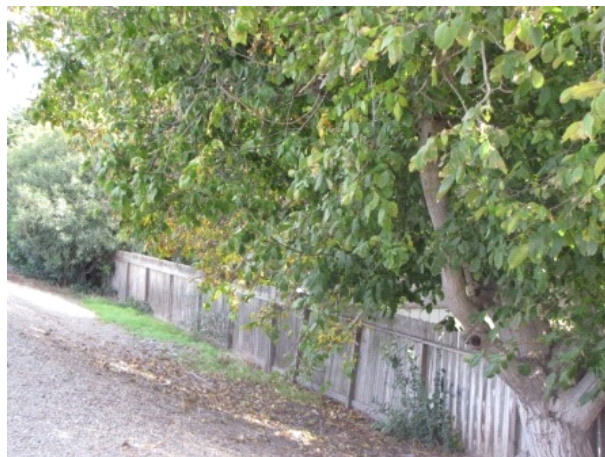
Levee Mile Report Line	79
Start Levee Mile	2.25
End Levee Mile	2.30
Location	Land Side
Category	Earthen Levee
Item	Encroachments

View of a wood fence at the landward toe.

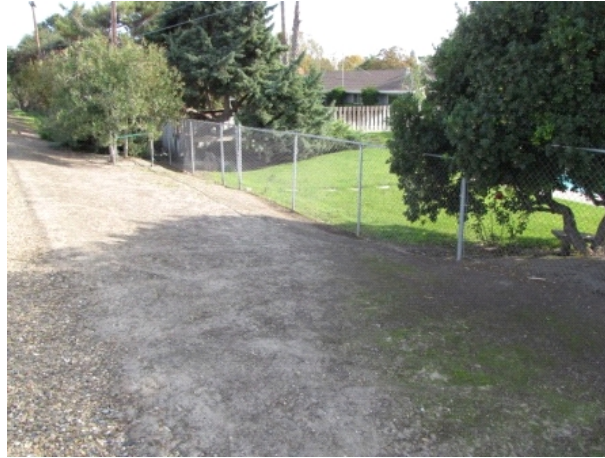
View of a fence on the landward slope looking upstream.

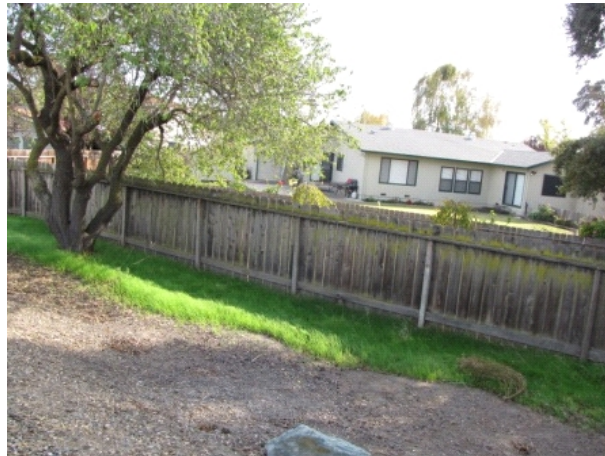
Levee Mile Report Line	85
Start Levee Mile	2.38
End Levee Mile	2.40
Location	Land Side
Category	Earthen Levee
Item	Encroachments

View of a fence at the landward toe.

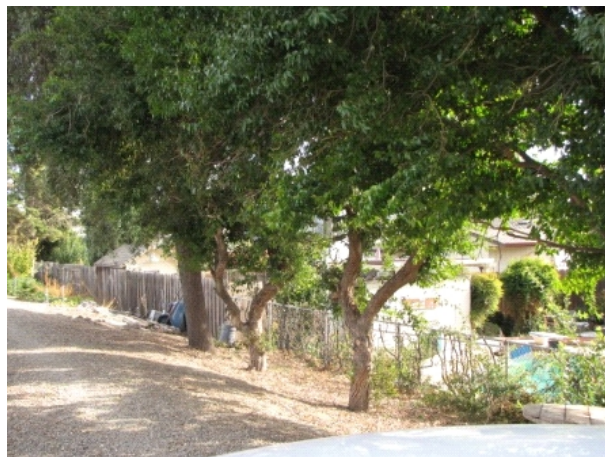
Levee Mile Report Line	86
Start Levee Mile	2.40
End Levee Mile	2.43
Location	Land Side
Category	Earthen Levee
Item	Encroachments

View of a fence at the landward toe.

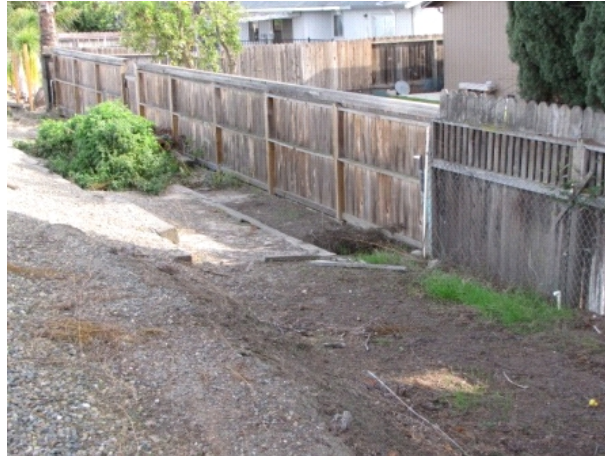
View of a fence at the landward toe looking upstream.

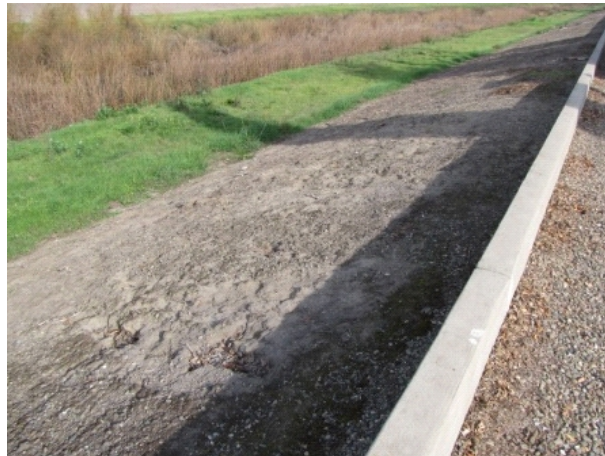
Levee Mile Report Line	89
Start Levee Mile	2.45
End Levee Mile	2.45
Location	Water Side
Category	Earthen Levee
Item	Erosion / Bank Caving

View of erosion occurring on the waterward slope likely due to a landowner pumping water from his pool looking upstream.

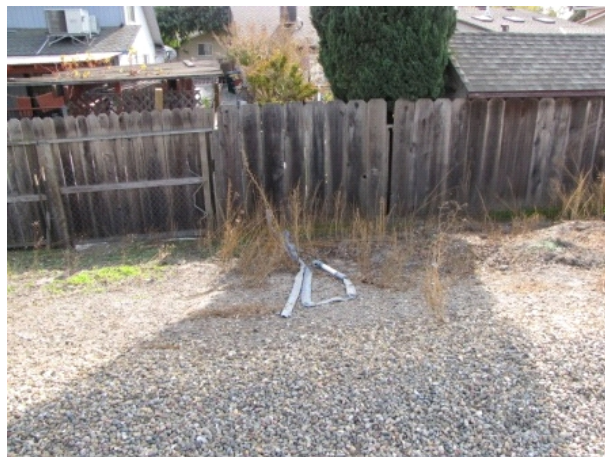
Levee Mile Report Line	89
Start Levee Mile	2.45
End Levee Mile	2.45
Location	Water Side
Category	Earthen Levee
Item	Erosion / Bank Caving

View of the hose likely used to pump the water to the waterward slope.

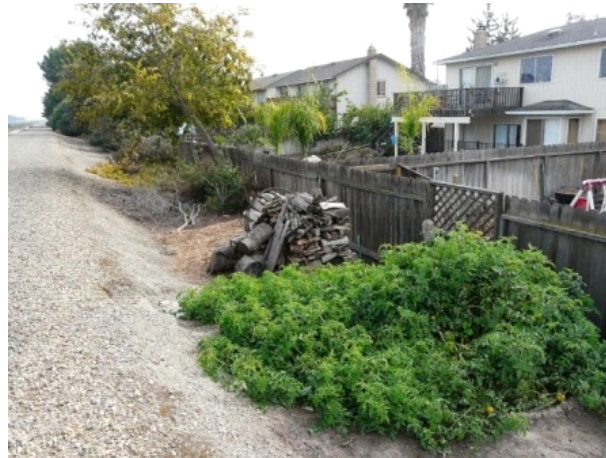
Levee Mile Report Line	92
Start Levee Mile	2.47
End Levee Mile	2.47
Location	Land Side
Category	Earthen Levee
Item	Encroachments
Remove firewood from landside of levee slope at LM 2.47	
dpesaven_f_20100928_087.JPG

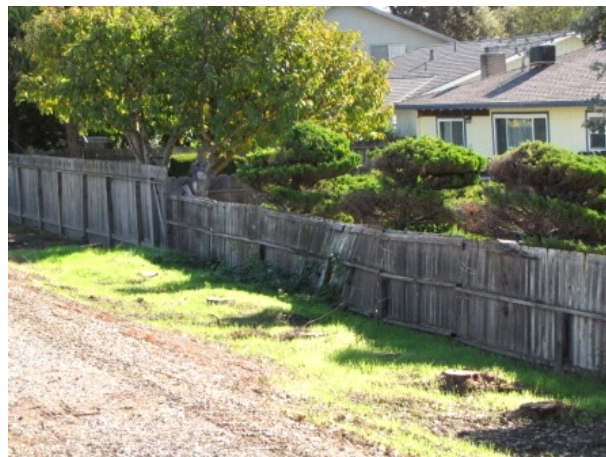
Levee Mile Report Line	96
Start Levee Mile	2.55
End Levee Mile	2.55
Location	Land Side
Category	Earthen Levee
Item	Trim / Thin Trees
View of stumps along the landward toe looking upstream.	
dpesaven_f_20101110_526.jpg

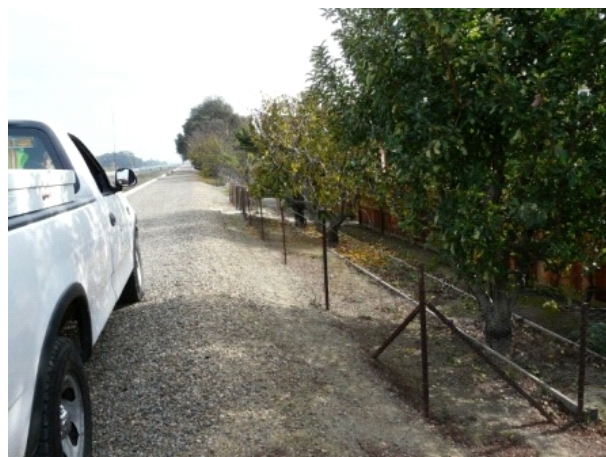
Levee Mile Report Line	97
Start Levee Mile	2.58
End Levee Mile	2.61
Location	Land Side
Category	Earthen Levee
Item	Encroachments
Fence located on sholder of landside of levee from LM 2.58 to LM 2.61	
dpesaven_f_20100928_088.JPG

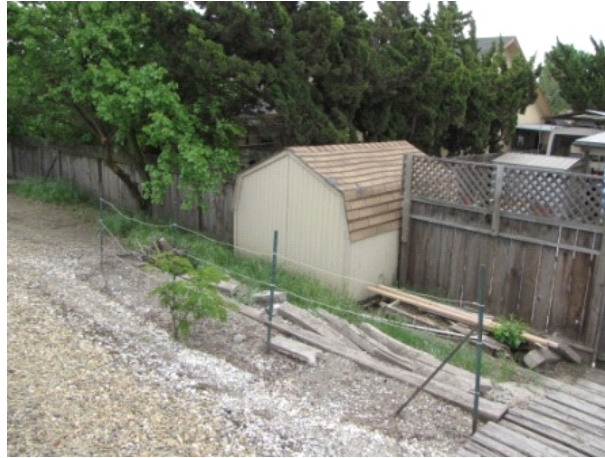
Landscaping and shed placed on landward levee slope and within 10' of the toe.

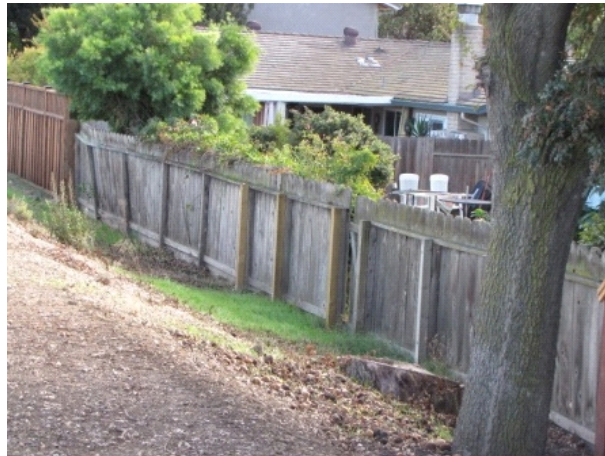
Levee Mile Report Line	115
Start Levee Mile	3.08
End Levee Mile	3.08
Location	Land Side
Category	Earthen Levee
Item	Trim / Thin Trees

View of a stump on the landward slope looking upstream.

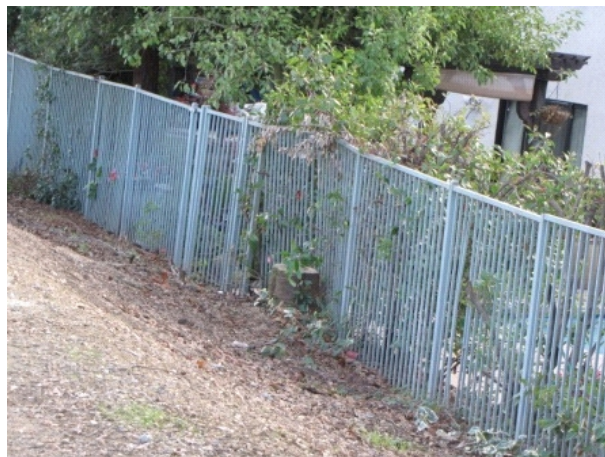
Levee Mile Report Line	117
Start Levee Mile	3.15
End Levee Mile	3.15
Location	Land Side
Category	Earthen Levee
Item	Trim / Thin Trees

View of a stump on the landward slope looking upstream.

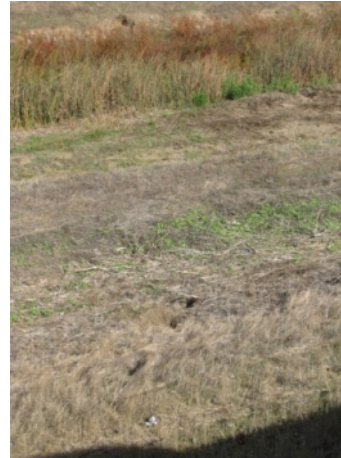
View of a large rodent hole at the waterward toe looking waterward and upstream.

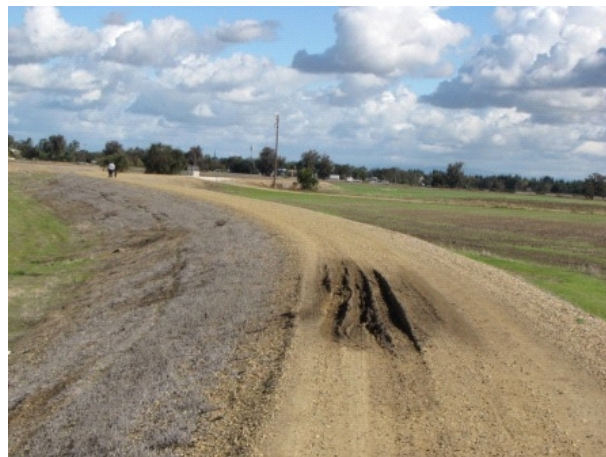
View of a moderate sized wet area along the crown where water has ponded and vehicle traffic has created ruts looking upstream.

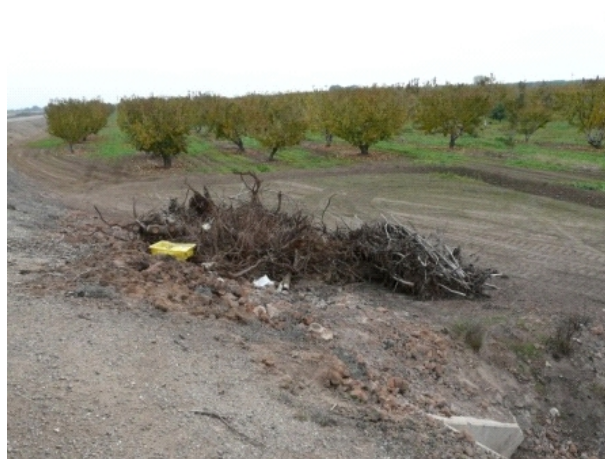
Levee Mile Report Line	138
Start Levee Mile	9.52
End Levee Mile	9.52
Location	Land Side
Category	Earthen Levee
Item	Encroachments
Remove prunings from landside of levee at LM 9.52	
dpesaven_f_20100928_093.JPG

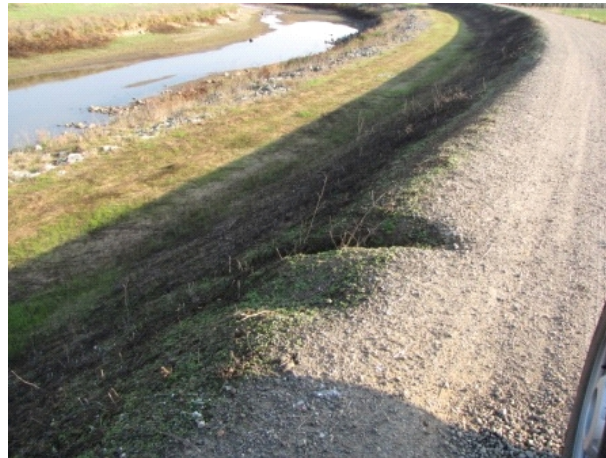
View of erosion on the waterward shoulder looking upstream.

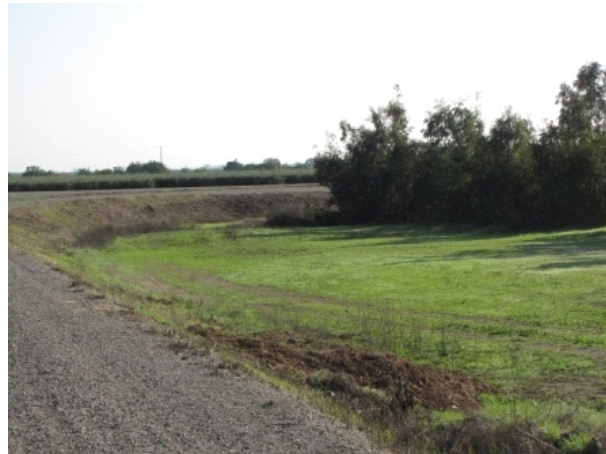
Levee Mile Report Line	144
Start Levee Mile	10.53
End Levee Mile	10.53
Location	Land Side
Category	Earthen Levee
Item	Encroachments

View of soil placed on the landward slope looking upstream.

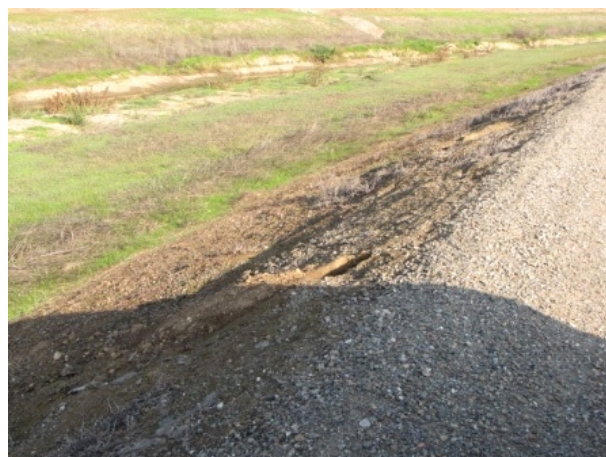
Levee Mile Report Line	146
Start Levee Mile	10.78
End Levee Mile	10.78
Location	Water Side
Category	Earthen Levee
Item	Animal Control

View of rodent holes in the waterward slope looking upstream.

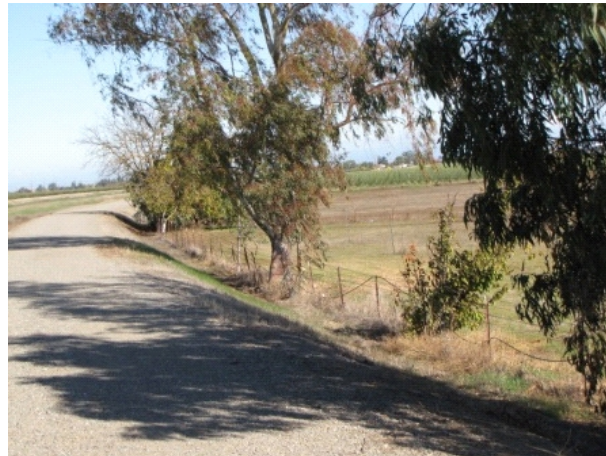
View of a fence at the landward toe looking upstream.

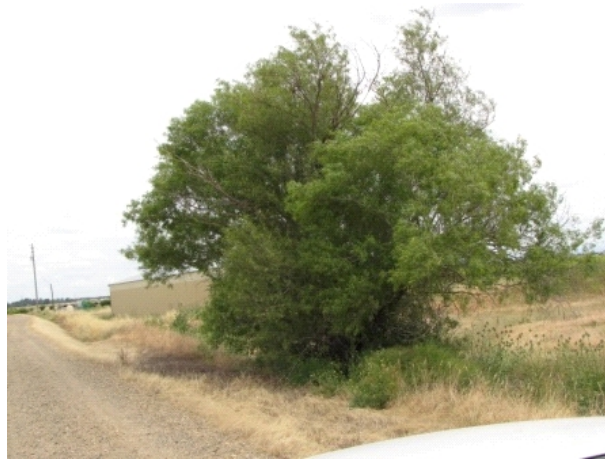
View of a tree blocking visibility on the landward slope looking upstream.

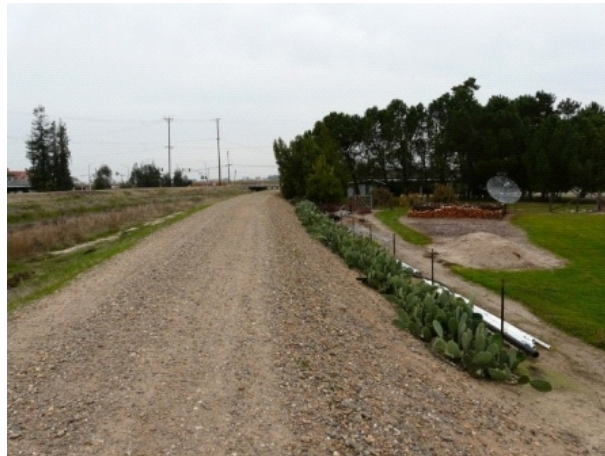
dpesaven_f_20100928_086.JPG

Landscaping along landside of levee from LM 13.51 to LM 13.59. Trim trees along landside of levee slope to allow for visibility from LM 13.54 to 13.59.

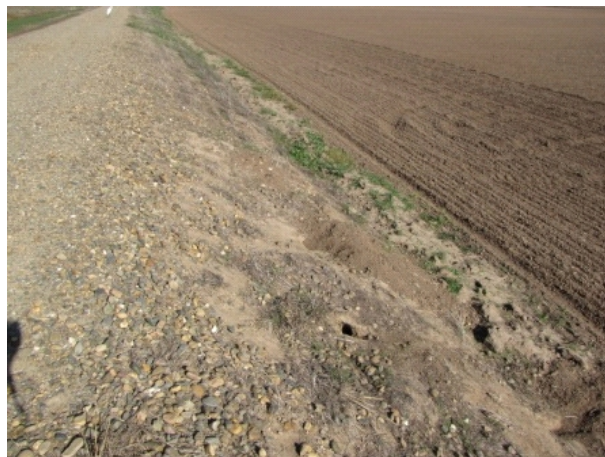
Levee Mile Report Line	173
Start Levee Mile	13.74
End Levee Mile	13.74
Location	Land Side
Category	Earthen Levee
Item	Animal Control

View of rodent activity on landward slope looking upstream.

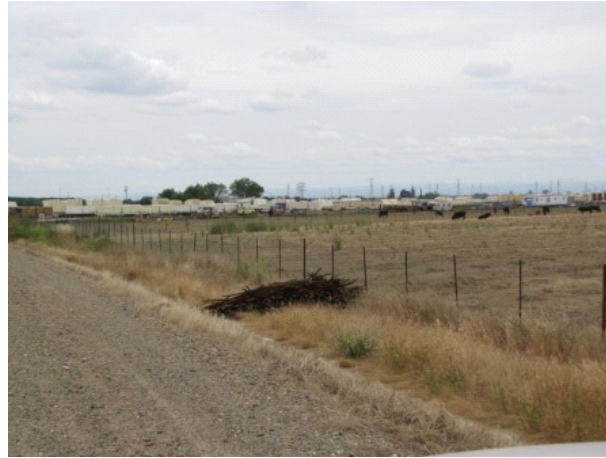
dpesaven_f_20100928_091.jpg

View of debris at the landward toe looking upstream.

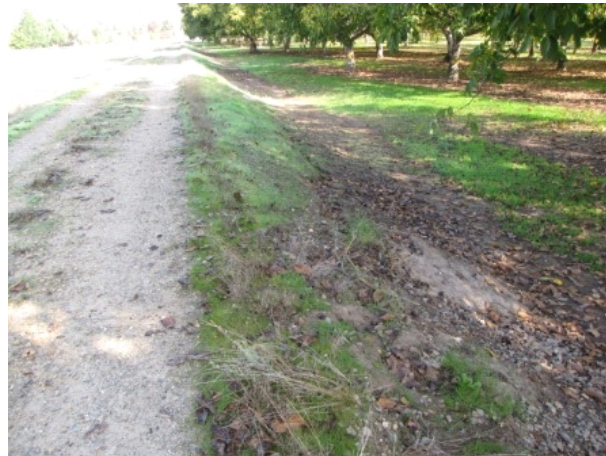
Levee Mile Report Line	184
Start Levee Mile	15.41
End Levee Mile	15.41
Location	Land Side
Category	Earthen Levee
Item	Animal Control

View of rodent activity on the landward slope looking upstream.

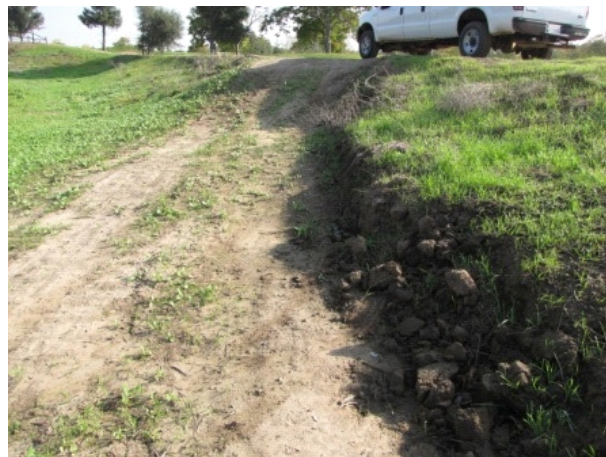
Levee Mile Report Line	186
Start Levee Mile	15.72
End Levee Mile	15.72
Location	Water Side
Category	Earthen Levee
Item	Slope Stability

View of the edge of a waterward ramp cutting into the slope looking upstream.

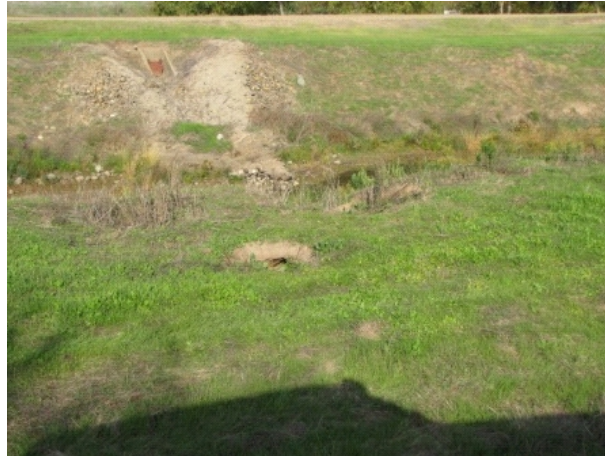
dpesaven_f_20101118_564.jpg

View of erosion on the shoulder of the waterward berm looking toward the channel.

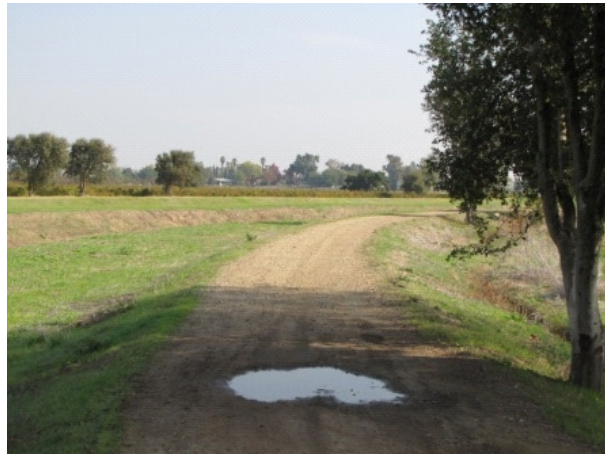
Levee Mile Report Line	189
Start Levee Mile	15.96
End Levee Mile	15.96
Location	Crown
Category	Earthen Levee
Item	Crown Surface / Depressions / Rutting

View of a pool of water in a depression on the crown looking upstream.

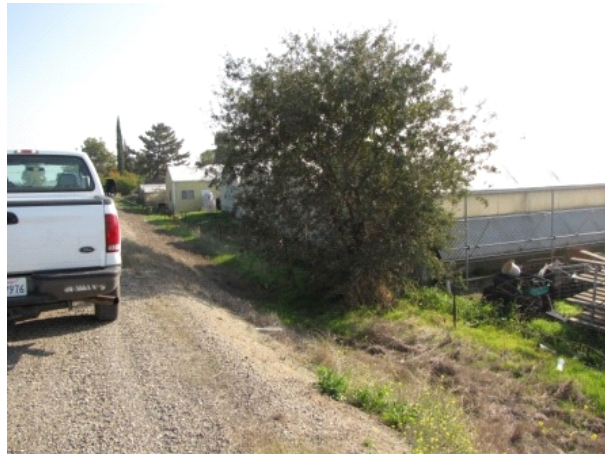
Levee Mile Report Line	3
Start Levee Mile	0.47
End Levee Mile	0.47
Location	Land Side
Category	Earthen Levee
Item	Trim / Thin Trees
View of a tree blocking visibility and access at the landward toe looking upstream.	
dpesaven_f_20101117_540.jpg

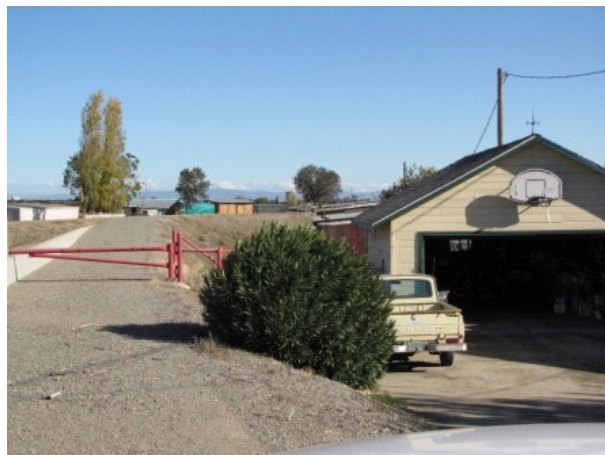
Levee Mile Report Line	4
Start Levee Mile	0.57
End Levee Mile	0.57
Location	Land Side
Category	Earthen Levee
Item	Encroachments
View of an oleander bush maintained by the landowner obstructing visibility and access looking upstream.	
dpesaven_f_20100928_196.jpg

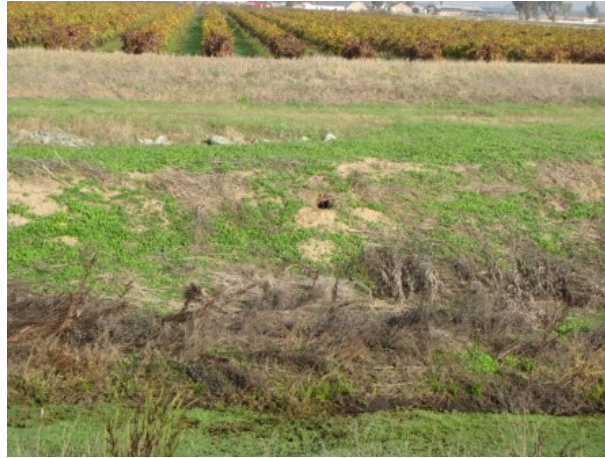
dpesaven_f_20101118_558.jpg

View of a large diameter hole in the waterward berm from across the channel.

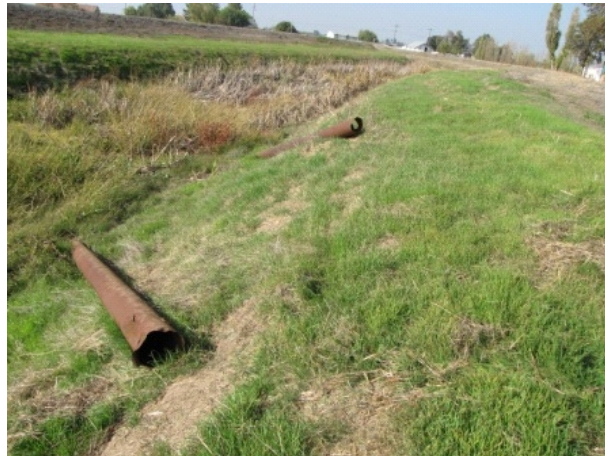
Levee Mile Report Line	4
Start Levee Mile	0.59
End Levee Mile	0.59
Location	Water Side
Category	Earthen Levee
Item	Encroachments

View of metal pipes laying in the channel looking downstream.

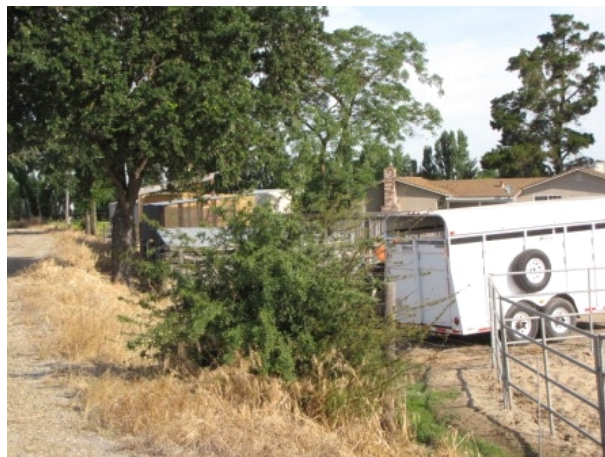
Levee Mile Report Line	5
Start Levee Mile	0.59
End Levee Mile	0.59
Location	Land Side
Category	Earthen Levee
Item	Trim / Thin Trees

View of a tree blocking visibility on the landward slope looking downstream.

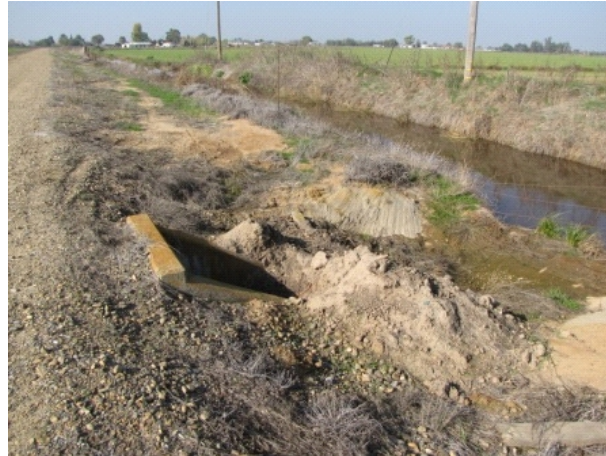
dpesaven_f_20101117_544.jpg

View of the entrance to the project drainage culvert blocked by soil placed by the landowner on the landward side looking downstream.

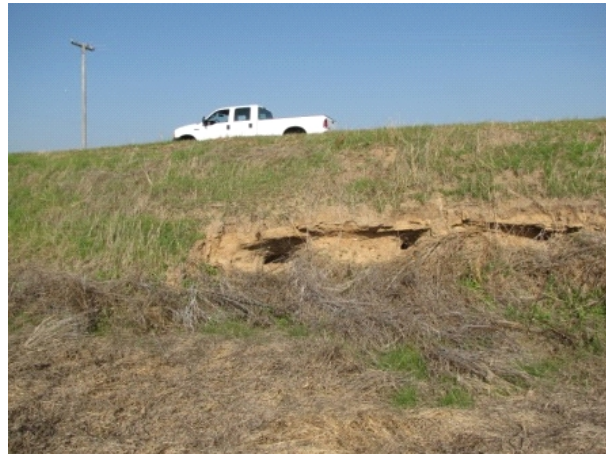
Levee Mile Report Line	8
Start Levee Mile	0.87
End Levee Mile	0.87
Location	Water Side
Category	Earthen Levee
Item	Animal Control

View of rodent holes in the waterward berm from the channel.

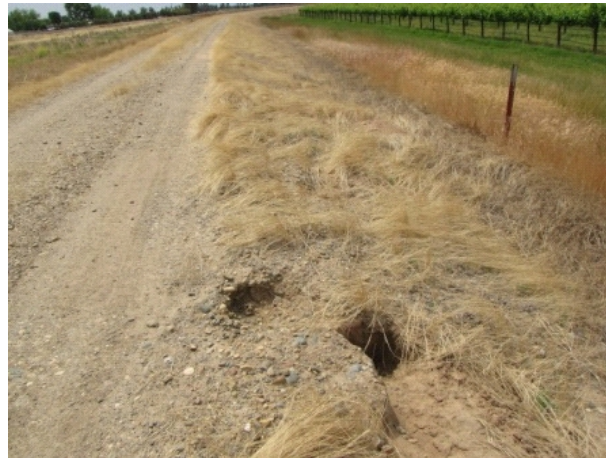
dpesaven_f_20100928_202.jpg

View of rodent holes in the landward slope looking downstream.

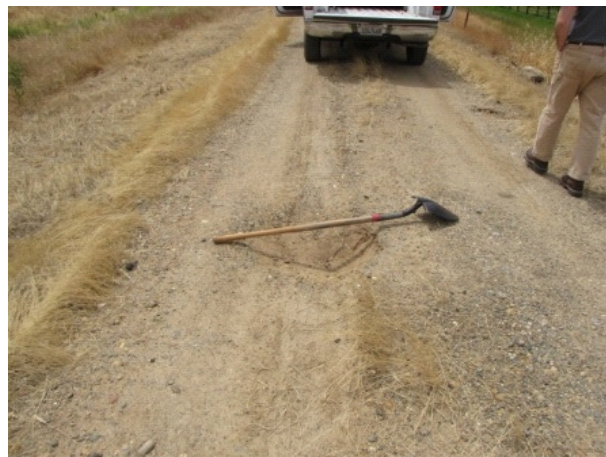
Levee Mile Report Line	2
Start Levee Mile	0.12
End Levee Mile	0.12
Location	Crown
Category	Earthen Levee
Item	Crown Surface / Depressions / Rutting

View of a depression in the crown with a depth of greater than 6 inches looking downstream.

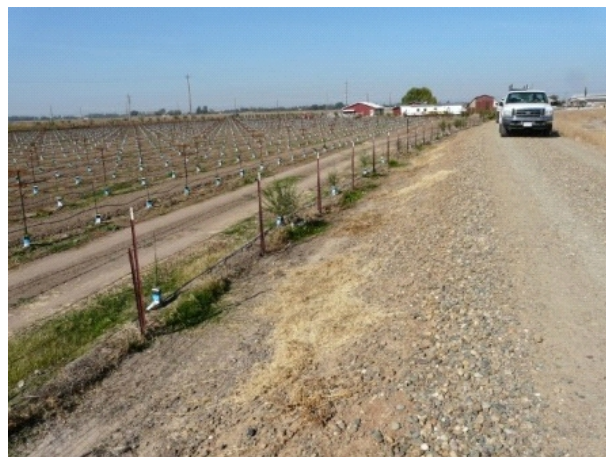
Levee Mile Report Line	3
Start Levee Mile	0.17
End Levee Mile	0.49
Location	Land Side
Category	Earthen Levee
Item	Encroachments

Fence located from LM 0.17 to LM 0.49 and crops located from LM 0.17 to LM 0.41 within 10' from landside toe of levee.

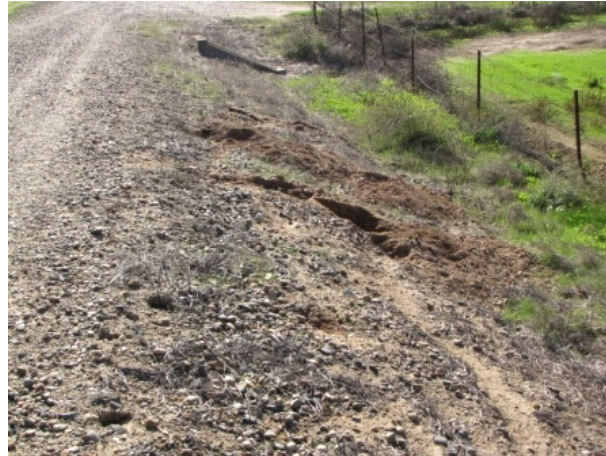
dpesaven_f_20101117_557.jpg

View of rodent holes in the landward slope looking downstream.

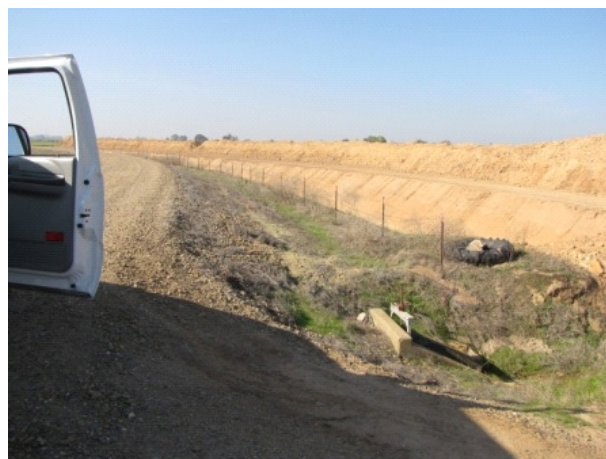
dpesaven_f_20101117_552.jpg

View of a large ditch adjacent to the landward toe of the levee looking along the landward toe, downstream at the upstream limit of the ditch.

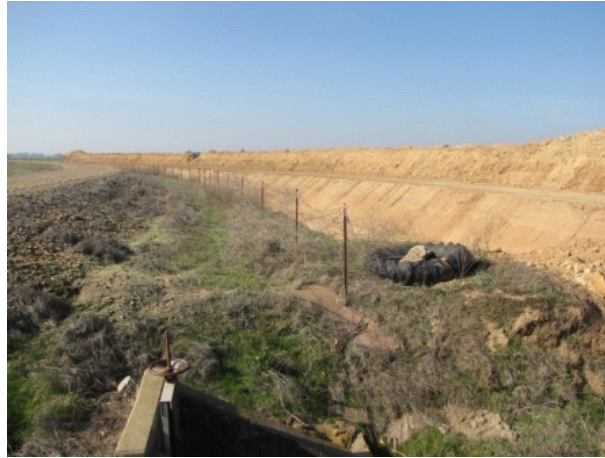
dpesaven_f_20101117_553.jpg

Additional view of the ditch looking along the landward toe, downstream at the upstream limit of the ditch.

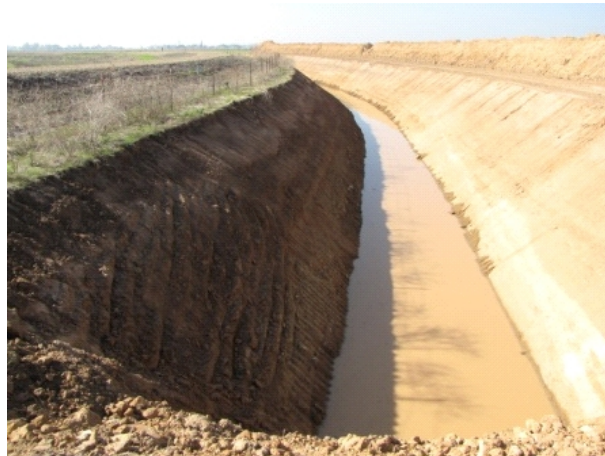
Levee Mile Report Line	11
Start Levee Mile	1.07
End Levee Mile	1.16
Location	Land Side
Category	Earthen Levee
Item	Slope Stability

View of the ditch adjacent to the landward toe looking upstream at the upstream limit of the ditch.

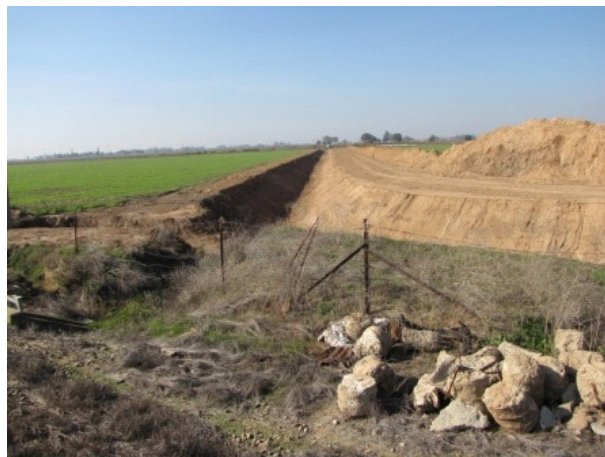
Levee Mile Report Line	11
Start Levee Mile	1.07
End Levee Mile	1.16
Location	Land Side
Category	Earthen Levee
Item	Slope Stability

View of the ditch adjacent to the landward toe of the levee looking landward at the downstream limit of the ditch.

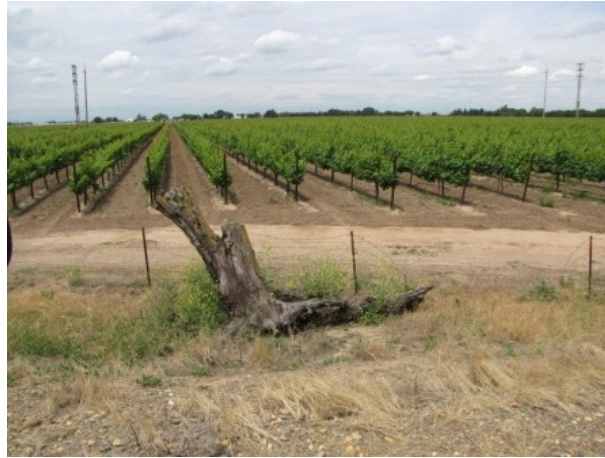
dpesaven_f_20100928_200.jpg

View of a tree stump on the landward slope.

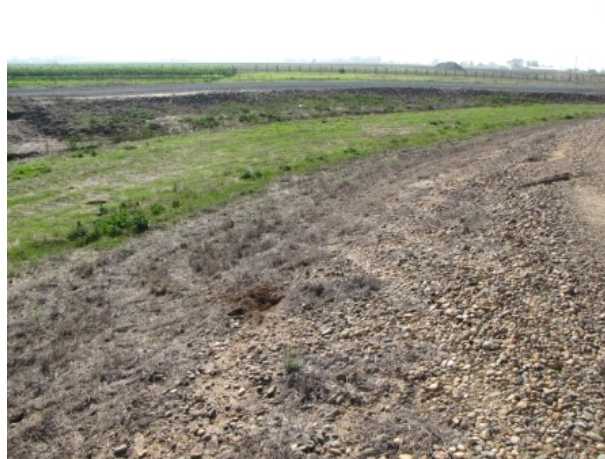
Levee Mile Report Line	13
Start Levee Mile	1.58
End Levee Mile	1.58
Location	Water Side
Category	Earthen Levee
Item	Animal Control

View of a rodent hole in the waterward slope looking downstream.

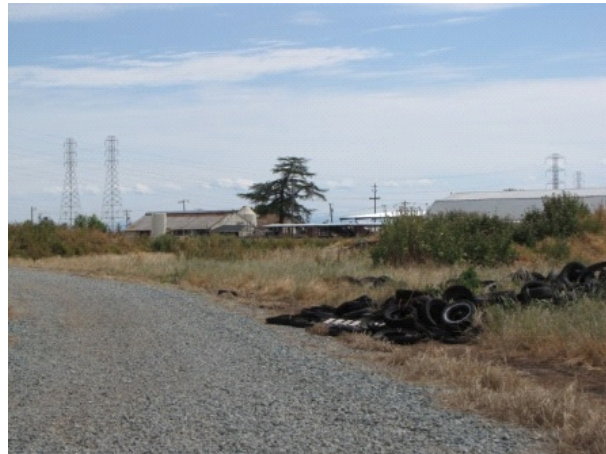
Levee Mile Report Line	6
Start Levee Mile	1.85
End Levee Mile	1.85
Location	Land Side
Category	Earthen Levee
Item	Encroachments
View of tires on the landward portion of the levee looking upstream.	
dpesaven_f_20100928_207.jpg
